*Final*  
**Survey Report**

**Surveys of Potential Wetland Sites on Tinian  
in Support of the  
Commonwealth of the Northern Mariana Islands  
Joint Military Training Environmental Impact Statement/  
Overseas Environmental Impact Statement**

March 2015

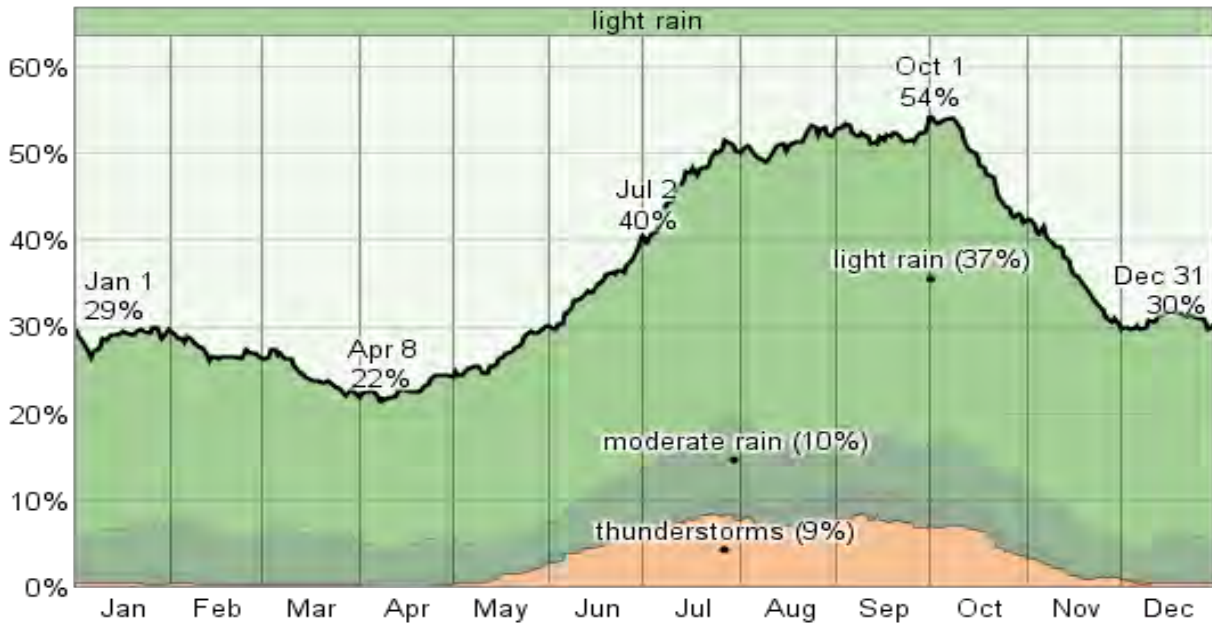
Figure 3 shows the probability of precipitation occurring at any given point in time during a typical year based on records from the Tinian International Airport. Historical precipitation values were averaged by month over time to provide a predication for the type and frequency of occurrence of precipitation that may occur on any given day. The graph plainly shows a distinct wet and dry season based on average precipitation. It should be cautioned that this data may not necessarily correlate with the amount of surface water at the Bateha and Mahalang sites during any specific point in time. For example, extremely high water levels were observed during field investigations conducted during the first week of December 2014 (Figure 4). Though precipitation was expected to be relatively low when examining historical average rainfall probabilities (Figure 3), there is a lag time between heavy rainfall events and when these potential wetland areas eventually dry out.

Data Interpretation: "The fraction of days in which various types of precipitation are observed. If more than one type of precipitation is reported in a given day, the more severe precipitation is counted. For example, if light rain is observed in the same day as a thunderstorm, that day counts towards the thunderstorm totals. The order of severity is from the top down in this graph, with the most severe at the bottom."

**Figure 3. Probability of Precipitation at Some Point in the Day for Tinian**

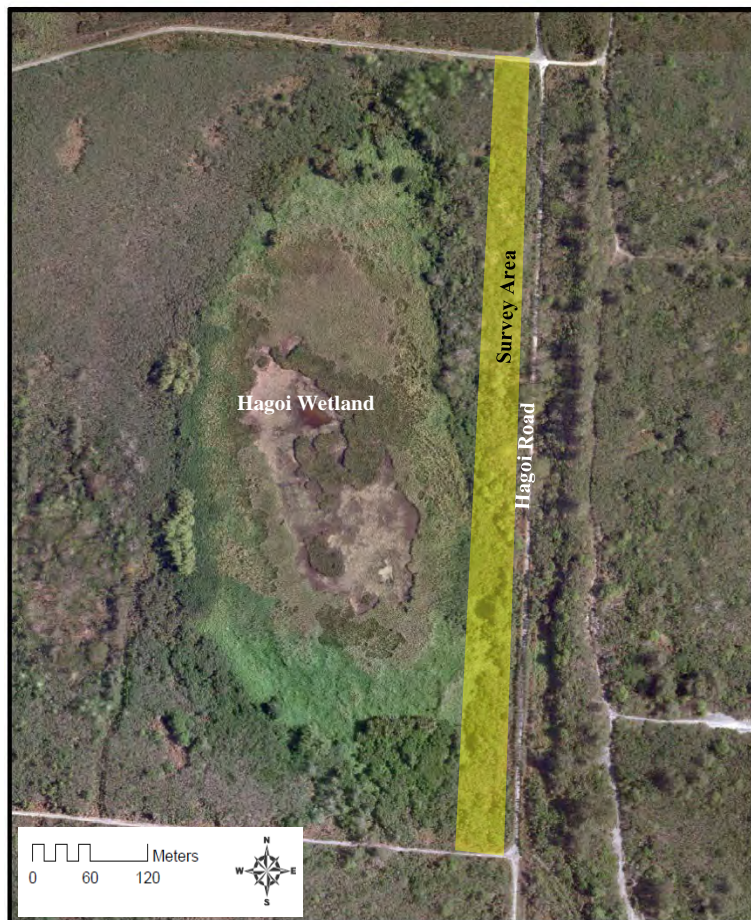
Figure 10. Hagoi Wetland and the Eastern Survey Area

The survey area includes the narrow strip of upland which is located between Hagoi Road and the Hagoi wetland. In order to determine the potential wetland/upland interface to the east of the Hagoi wetland and west of Hagoi Road, six soil test pits were dug approximately 50 ft (15 m) west of Hagoi Road at approximate 400-ft (120-m) intervals (Figure 11). The site is level with a slight <1% slope towards the Hagoi wetland. Test pits were dug to a depth of 16-20 in (41-51 cm) until hard, compacted material was encountered. At one location (soil test pit #2) concrete was found within a few inches of the soil surface so the test pit was relocated further away from the roadway.

Although Hagoi has not been identified by the USACE as a jurisdictional wetland, it is generally assumed to meet the definition of a jurisdictional wetland under the CWA. Hagoi wetland is surrounded on three sides by WWII-era paved roads (Figures 2 and 10). The area of interest is immediately adjacent to a road approximately 2,800 ft (853 m) in length and runs in a N-S direction along the eastern side of the Hagoi wetland. For purposes of this report, this particular road section is designated Hagoi Road. The road bed is raised approximately 5 ft (1.5 m) above surrounding terrain.

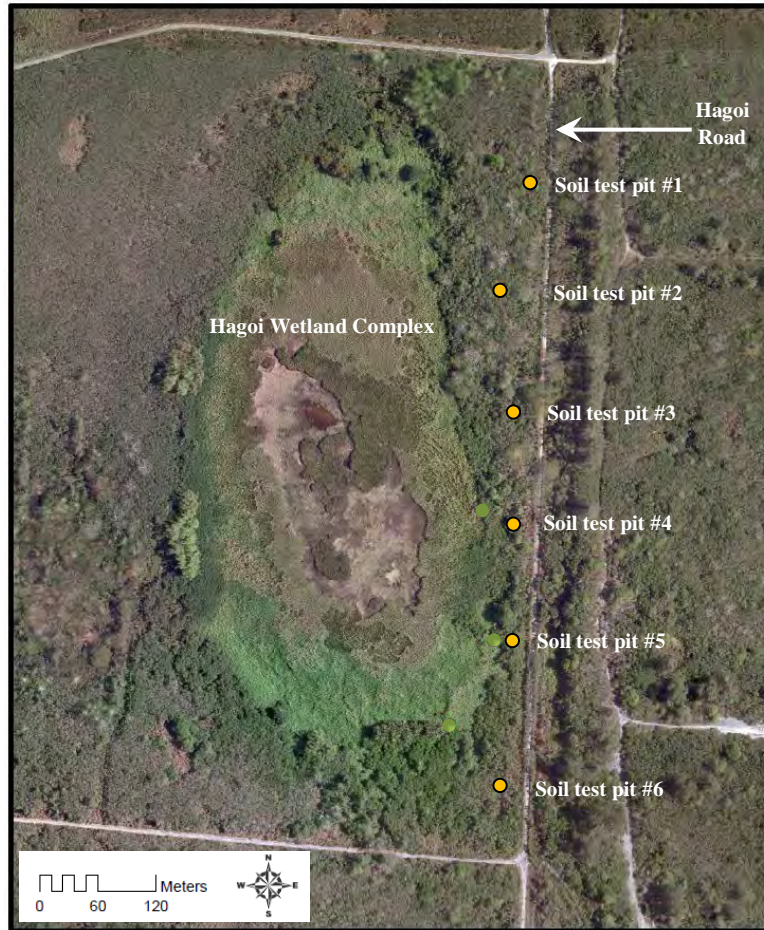
**Figure 11. Hagoi Wetland Complex Depicting the Soil Test Pits adjacent to the Western Side of Hagoi Road**

(Note: Data are superimposed onto an undated aerial photograph.)

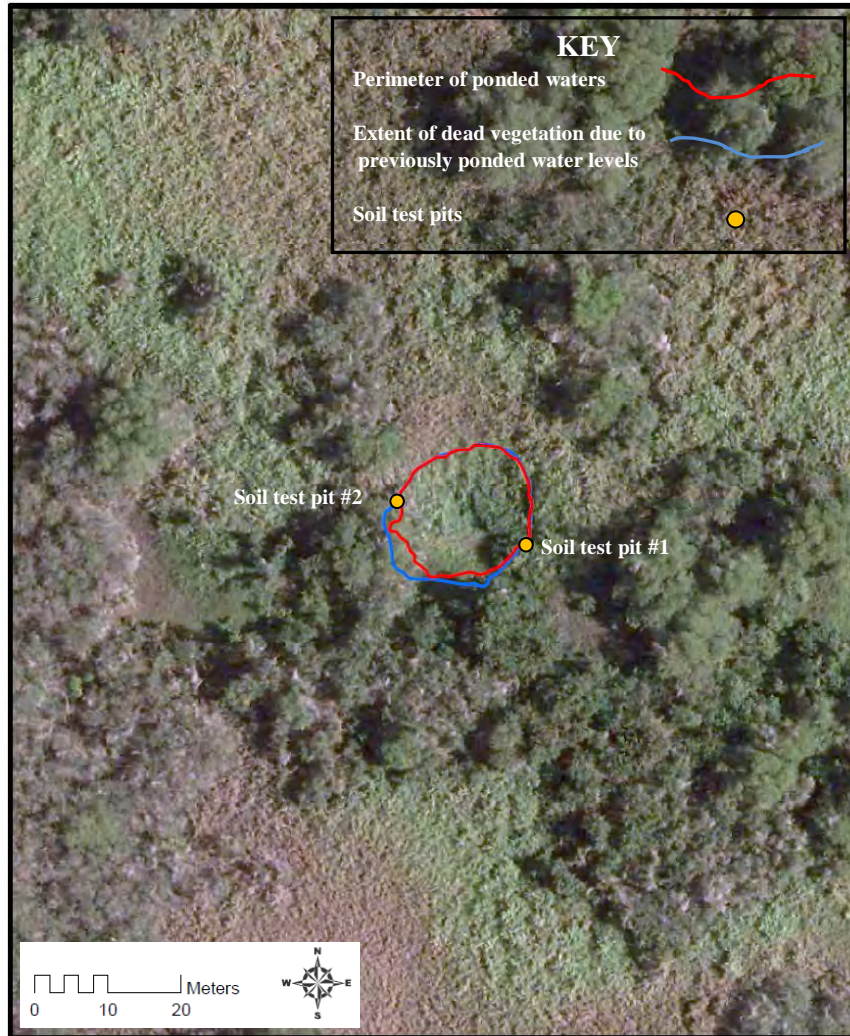
This crater site is a roundish steeply sloped tree-less conical depression. Table 2 shows select physical and ponding characteristics for this crater site and Figure 13 depicts the perimeters of the previously ponded water line and existing water line as of December 4, 2014. Water levels were the highest observed during the current field investigation with previously ponded waters covering an area of 3,412 square feet (ft<sup>2</sup>) (317 square meters [m<sup>2</sup>]) while ponded waters were 2,982 ft<sup>2</sup> (277 m<sup>2</sup>). On December 30-31, 2013, the area of previously ponded waters was estimated at 2,088 ft<sup>2</sup> (194 m<sup>2</sup>) while ponded waters covered 1,421 ft<sup>2</sup> (132 m<sup>2</sup>) (Table 2).

**Figure 13. Mahalang Site MC1 Depicting Soil Test Pits and Perimeters of the Previously Ponded Water Line and Existing Water Line as of December 4, 2014**

(Notes: Perimeter of previously ponded waters was defined by the demarcation line of dead vegetation. Locations of the two soil test pits are also noted. Data are superimposed onto an undated aerial photograph.)

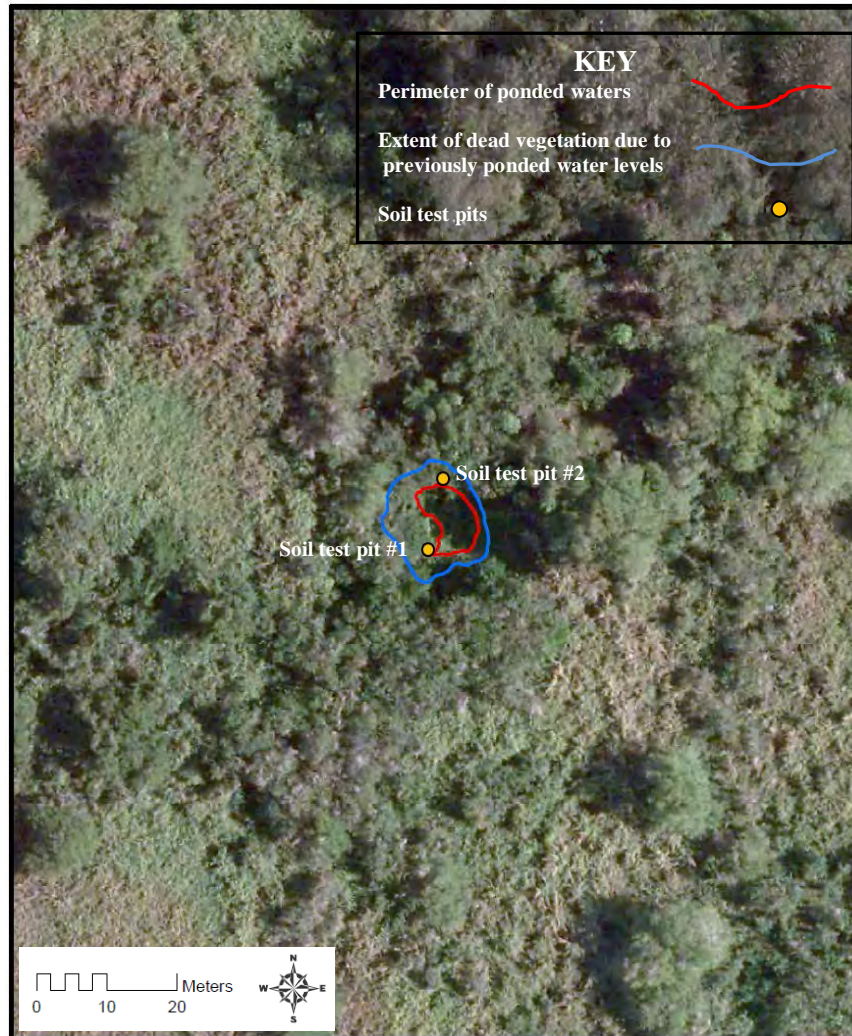
A short non-distinct surface drainage feature was found along the west side of the crater. No other surface drainage features were observed leading into/from this crater site or connecting this site with other surface water bodies.

**Figure 14. Mahalang Site MC2 Depicting the Soil Test Pits and Perimeters of the Previously Ponded Water Line and Existing Water Line as Mapped on December 4, 2014**

(Notes: Perimeter of previously ponded waters was defined by the demarcation line of dead vegetation. Locations of the two soil test pits are also noted. Data are superimposed onto an undated aerial photograph.)

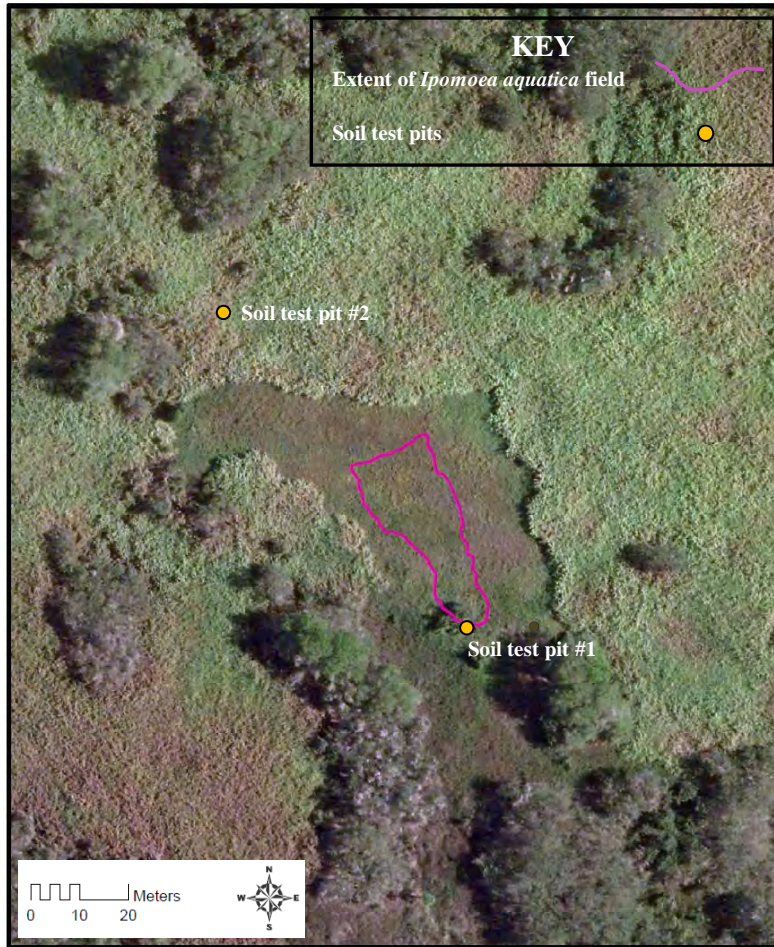
In the fall of 2012, the water was approximately 4-5 inches (in) (10-12.7 centimeters [cm]) deep. The previously ponded water line was distinct and measured on January 8, 2013, and the area was estimated to be 0.46 ac (0.19 ha) in size. This site was surveyed on December 3, 2014 and found to be flooded with a maximum depth of approximately 4 ft (1.2 m). Lateral expansion of ponded waters was so extensive that the edge was not distinguishable under the thick mat of dead *Pennisetum*. In addition, the previously ponded water line was not visible. While open water was not visually observed at this site in December 2014 due to the dense mats of *Ipomoea*, ponded water was found under the *Ipomoea*. Figure 15 depicts the perimeter of the *Ipomoea* field as of December 3, 2014.

**Figure 15. Mahalang Site MD3 Depicting the Soil Test Pits and Perimeter of the *Ipomoea aquatica* Field Mapped on December 3, 2014**

(Notes: The area covered by *Ipomoea* was 5,102 ft<sup>2</sup> (474 m<sup>2</sup>). Data are superimposed onto an undated aerial photograph.)

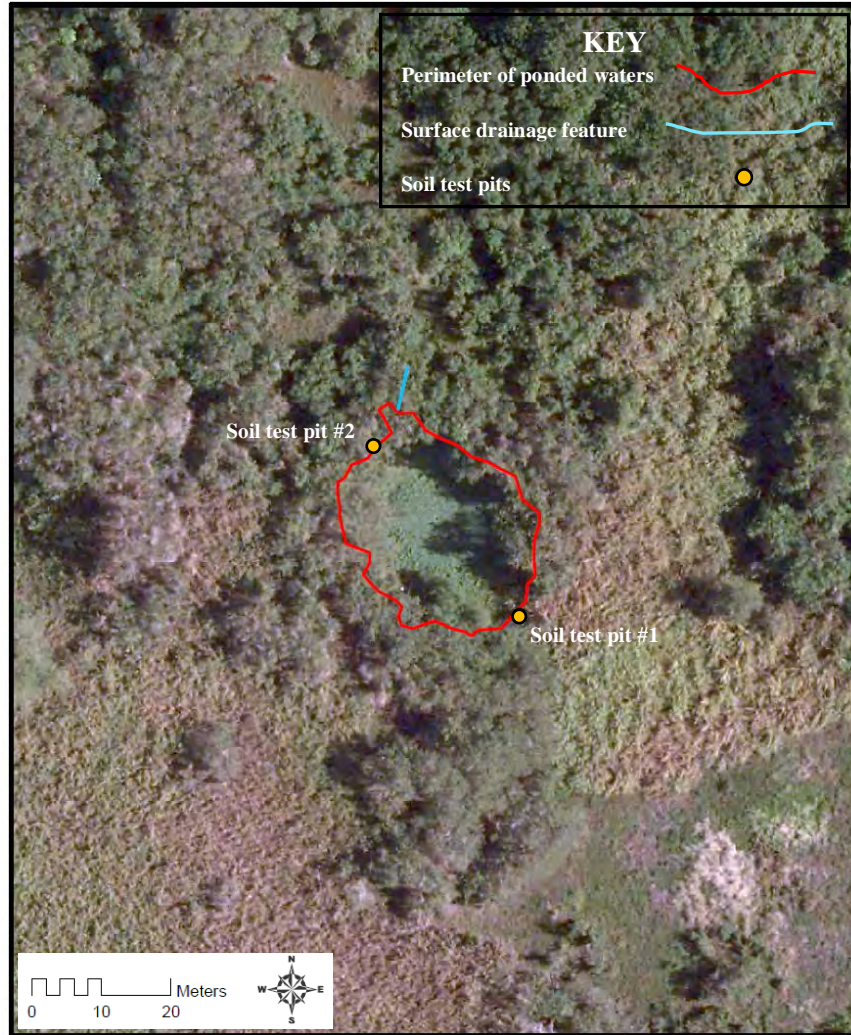
Two soil test pits were dug just above the water line (Figure 17). Although the soils at test pit #1 were not hydric, it should be noted that this test pit was sited fairly high on the crater slope due to the high water levels. Soil test pit #2 contained hydric soils.

**Figure 17. Mahalang Site M10 Depicting the Soil Test Pits and Perimeter of the Existing Pondered Water Line as Mapped on December 3, 2014.**

(Note: Data are superimposed onto an undated aerial photograph.)

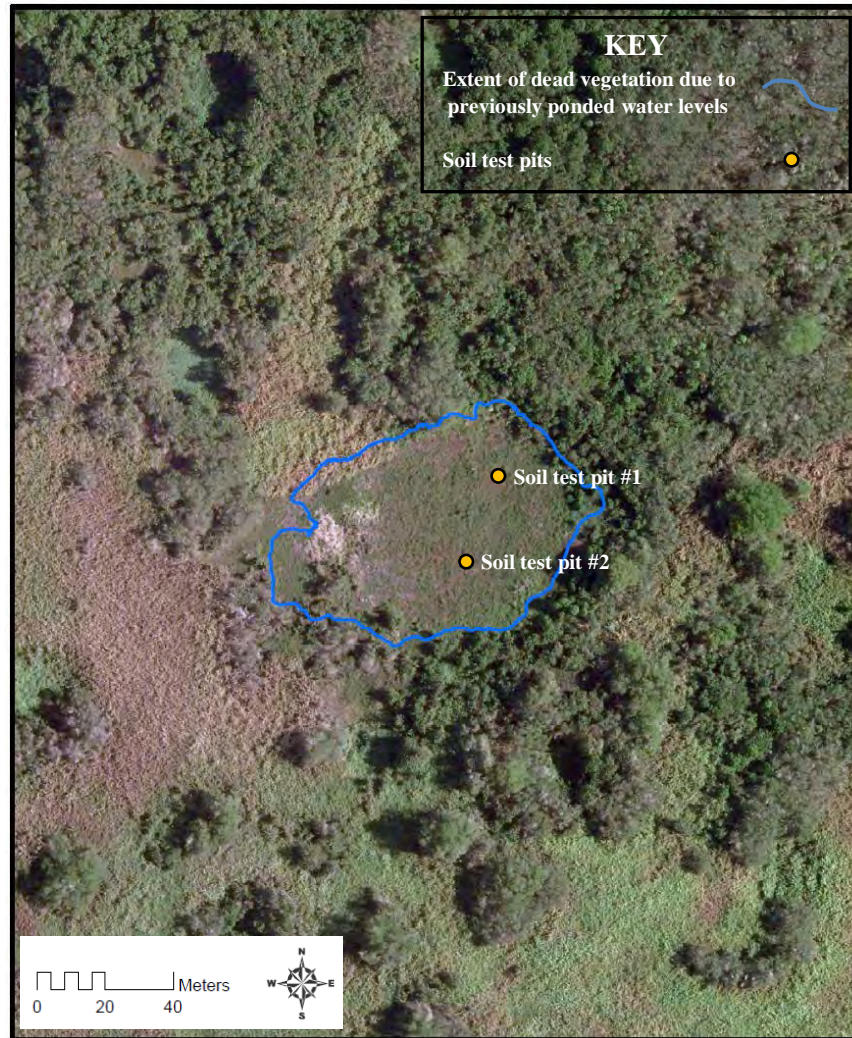
At the time of the field investigation, the site was dry with no groundwater or moisture present in the soil test pits. However, there is obvious evidence of earlier flooding by the presence of a dense, homogeneous stand of dead *Mimosa pudica* (facultative upland).

**Figure 18. Mahalang Site M11 Depicting the Soil Test Pits and Perimeter of the Previously Ponded Water Line as Mapped on December 3, 2014**

(Notes: Perimeter of previously ponded waters was defined by the demarcation line of dead vegetation. Site was completely dry with no ponded waters or wet areas. Data are superimposed onto an undated aerial photograph.)

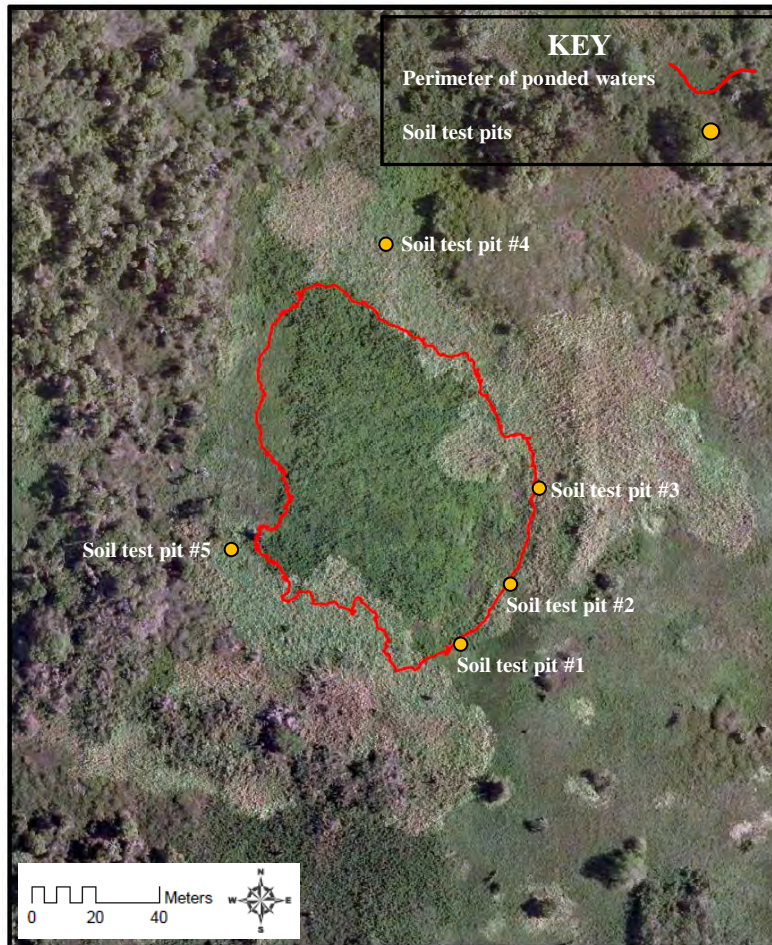
Table 3 shows select physical and ponding characteristics for this site and Figure 20 depicts the perimeter of the existing water line as of December 1, 2014. In January 2013, the estimated area of previously ponded waters was 2.7 ac (1.10 ha), while there were no ponded waters in December 2013 due to dry conditions. Current surveys in December 2014 estimated the area of existing ponded waters to be 1.85 ac (0.75 ha) (Table 3).

**Figure 20. Bateha Site BD2 Depicting the Soil Test Pits and Perimeter of the Existing Ponded Water Line as Mapped on December 1, 2014**  
(Note: Data are superimposed onto an undated aerial photograph.)

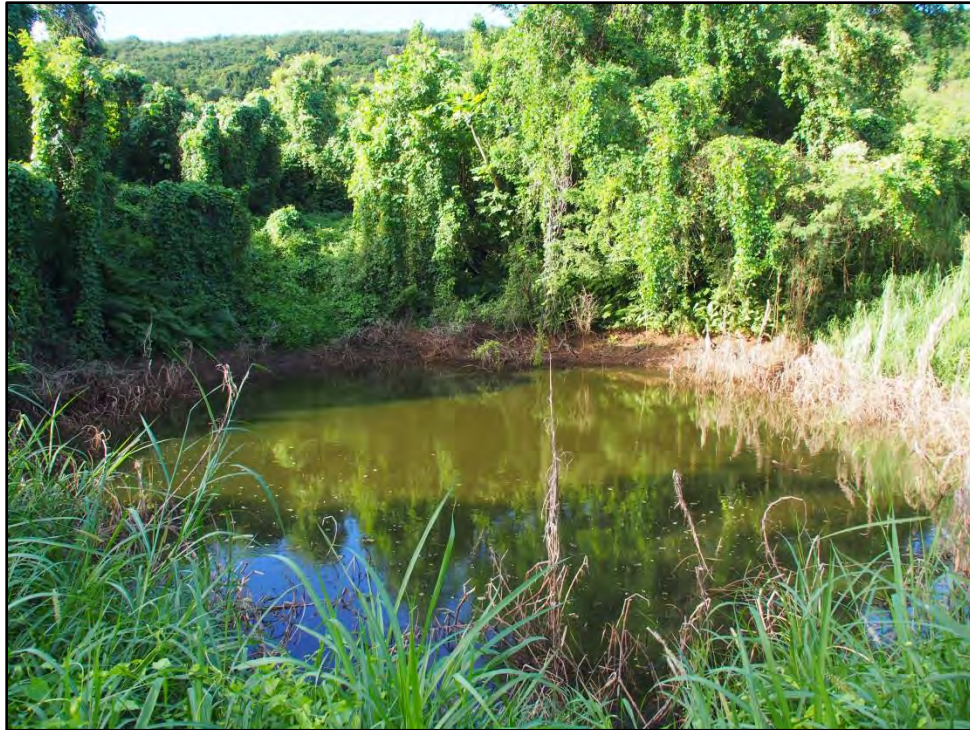
**Figure A-1. Photograph of MC1 site taken on December 4, 2014 showing high ponded water levels during the survey period.**

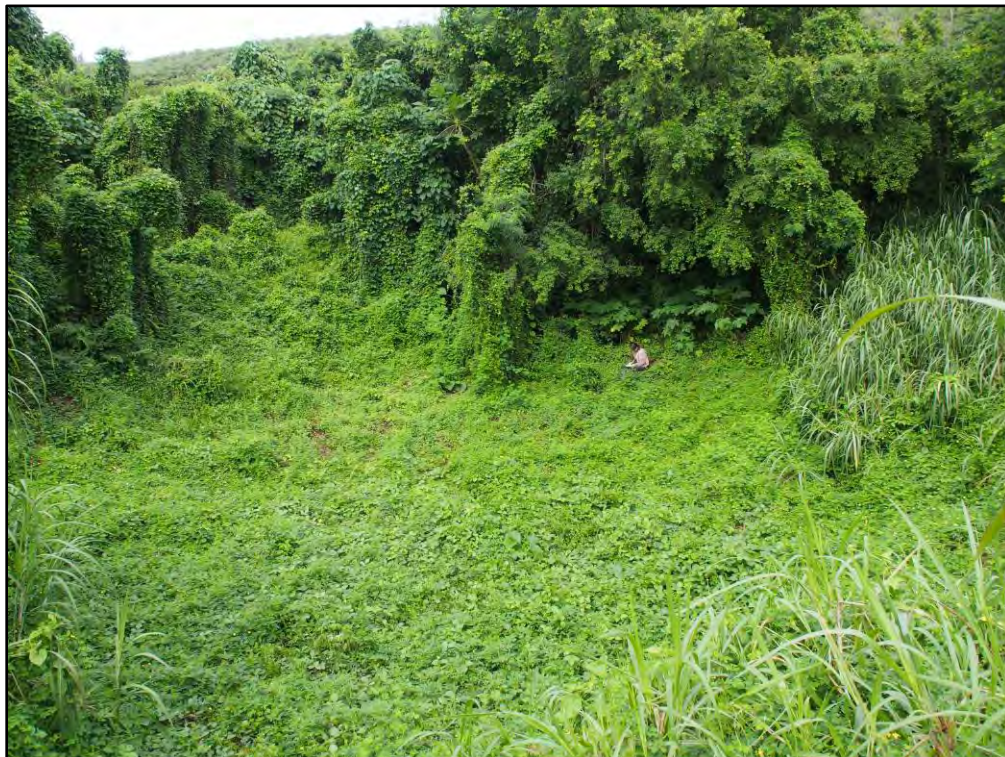
**Figure A-2. Photograph of MC1 taken on July 17, 2013 showing dominance of upland field vegetation.**

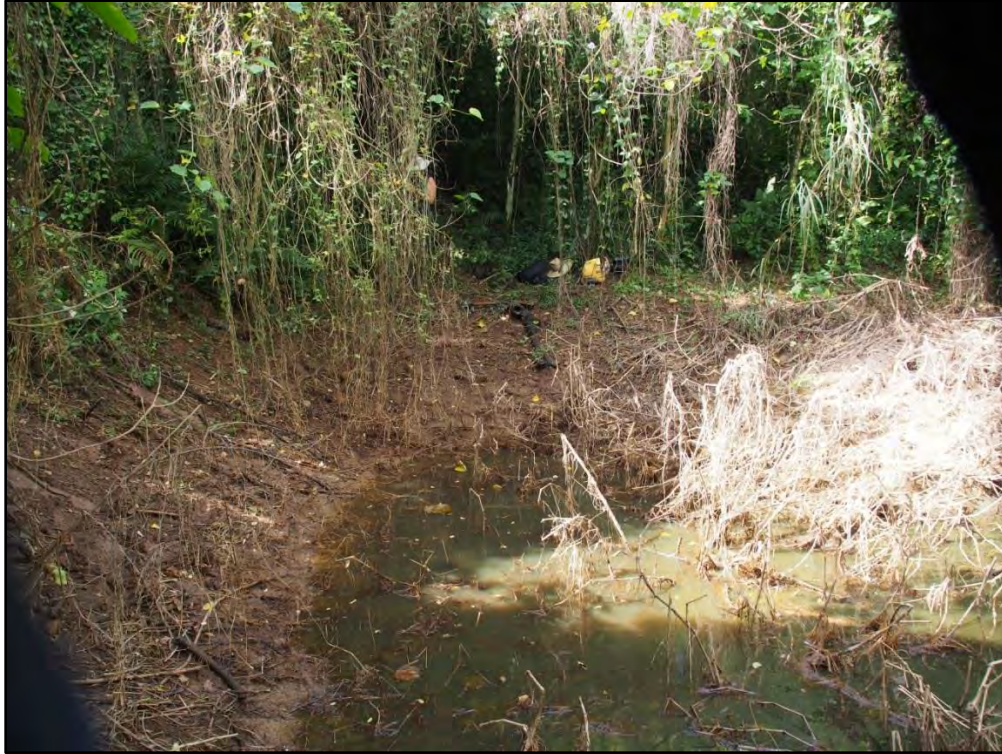
**Figure A-3. Photograph of MC2 taken on December 4, 2014 during the survey period.**

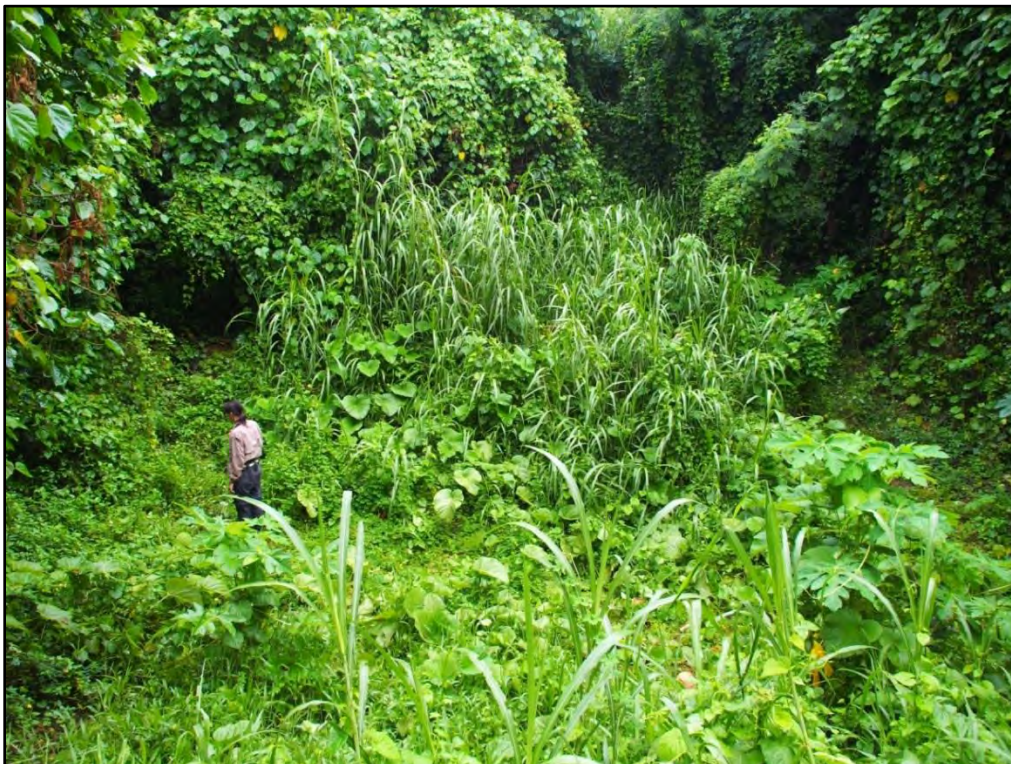
**Figure A-4. Photograph of MC2 taken on July 17, 2013 showing dominance of upland open field vegetation.**

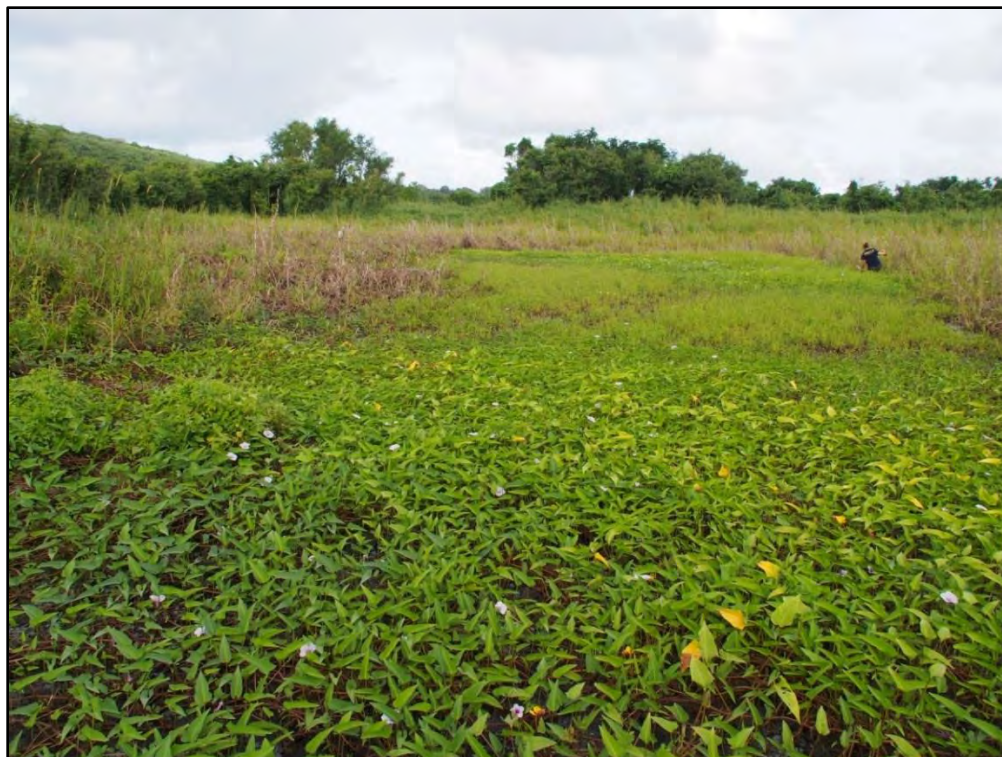
**Figure A-5. Photograph of MD3 taken on December 3, 2014 showing dominance of *Ipomoea aquatica* mats that overlie ponded waters.**

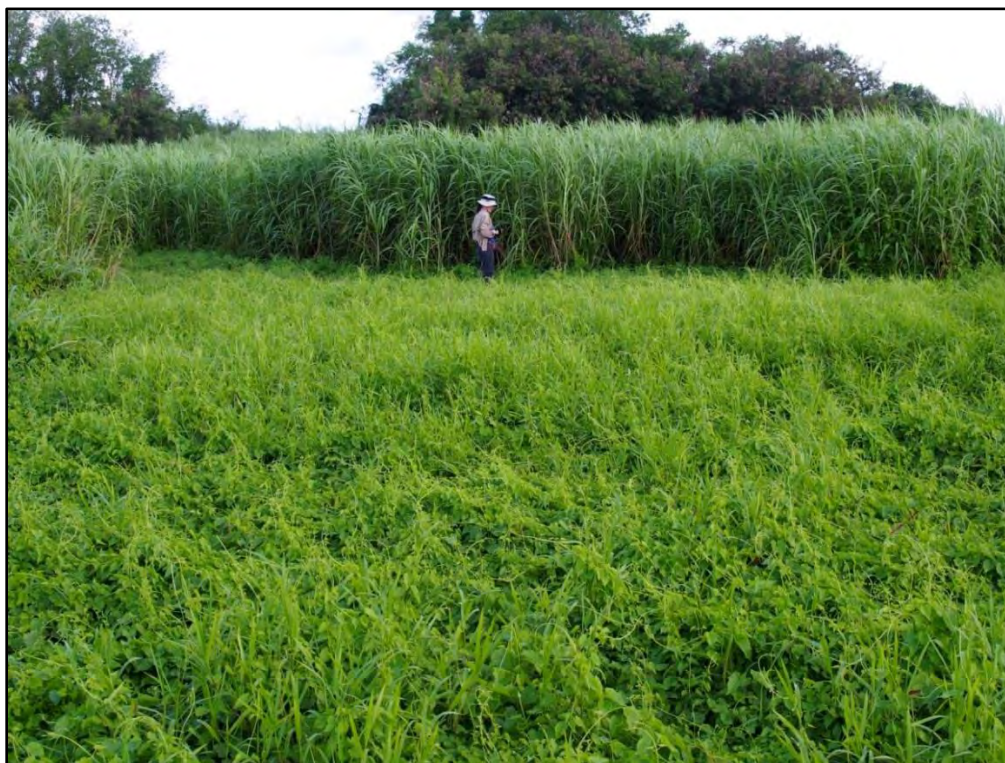
**Figure A-6. Photograph of MD3 taken on July 4, 2013 showing a significant decrease in the dominance of *Ipomoea aquatica*.**

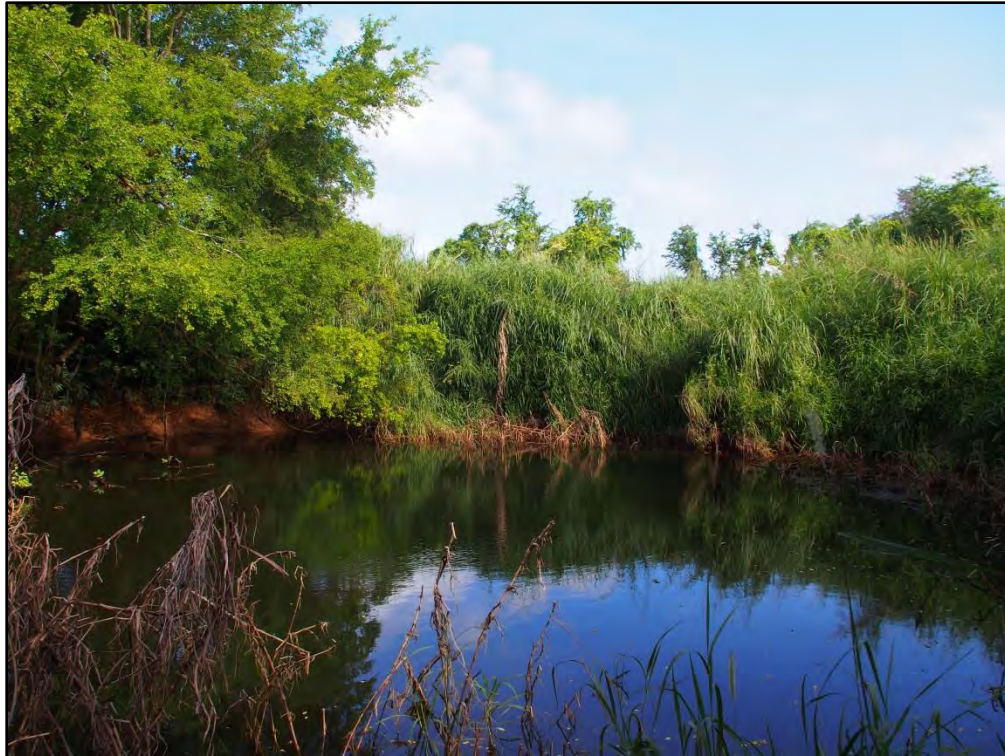
**Figure A-7. Photograph of M07 taken on December 4, 2014 showing the high ponded water levels during the survey period.**

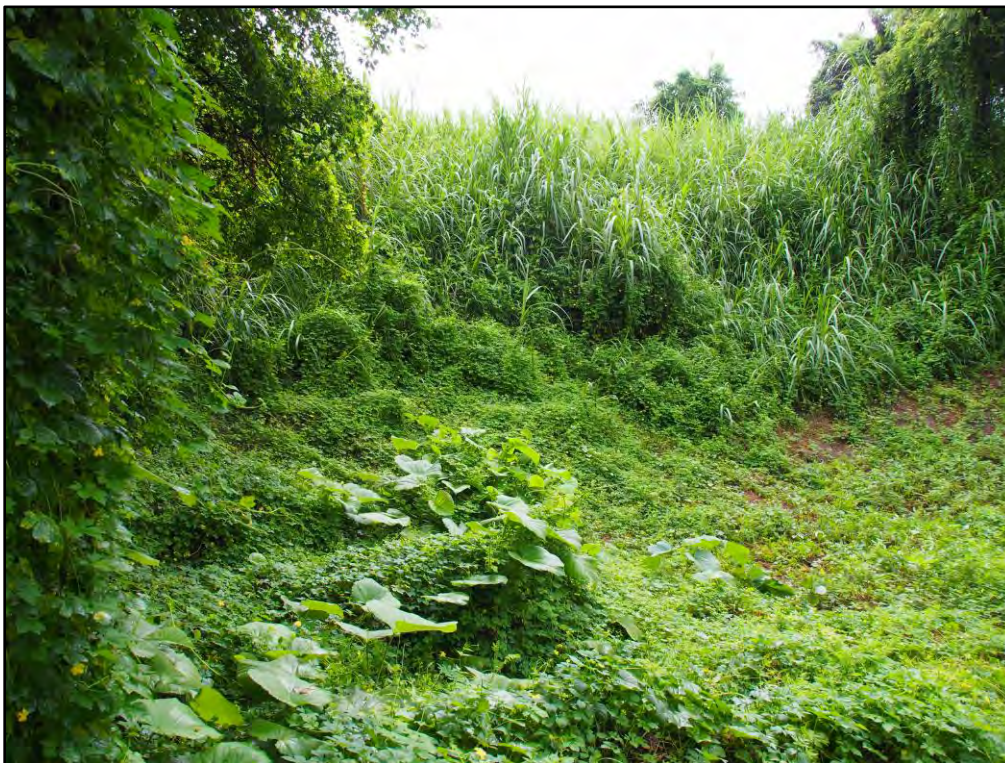
**Figure A-8. Photograph of M07 taken on July 17, 2013 showing a dominance of upland open field vegetation.**

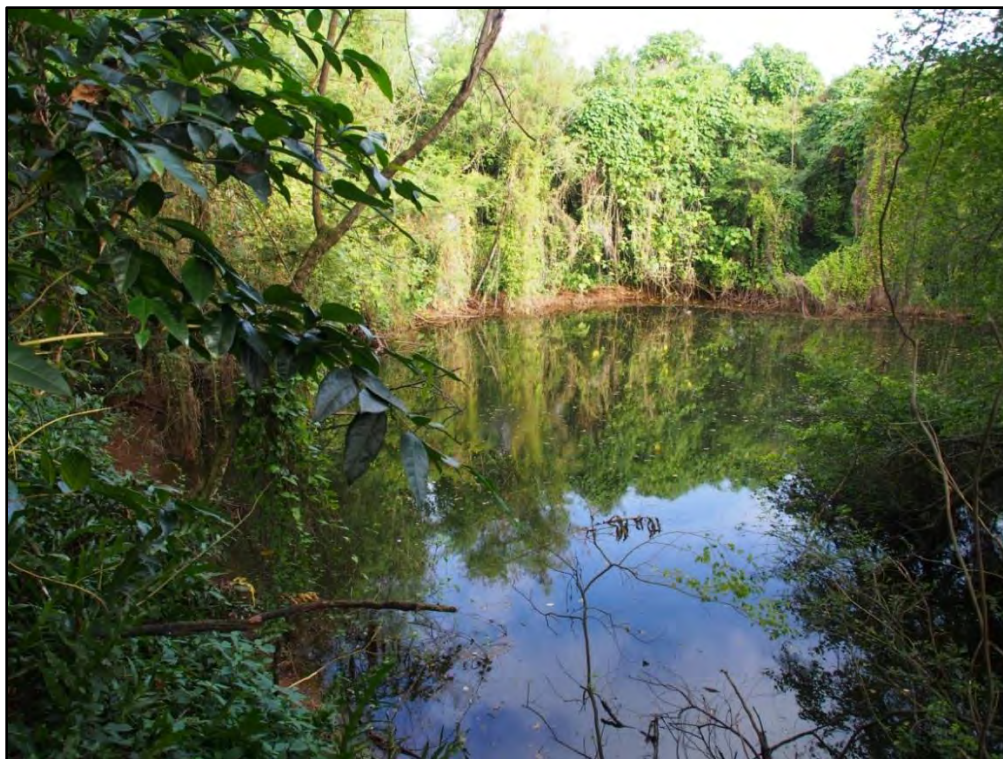
**Figure A-9. Photograph of M10 taken on December 4, 2014 during the survey period.**

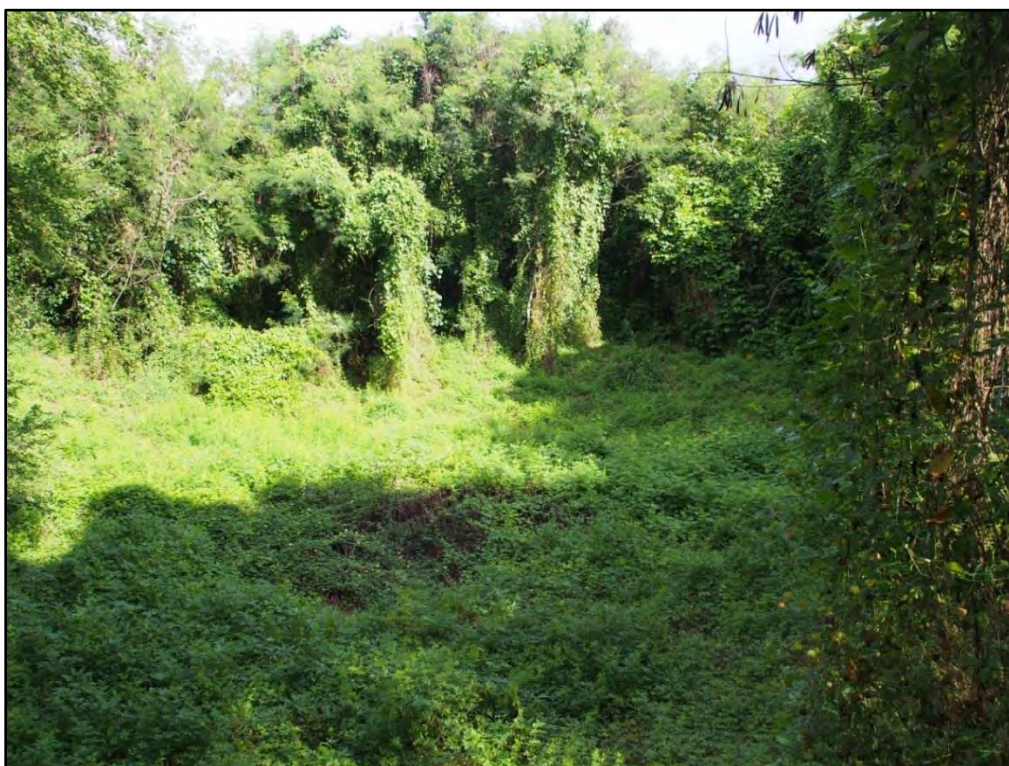
**Figure A-10. Photograph of M10 taken on August 18, 2013 showing dominance of upland open field vegetation.**

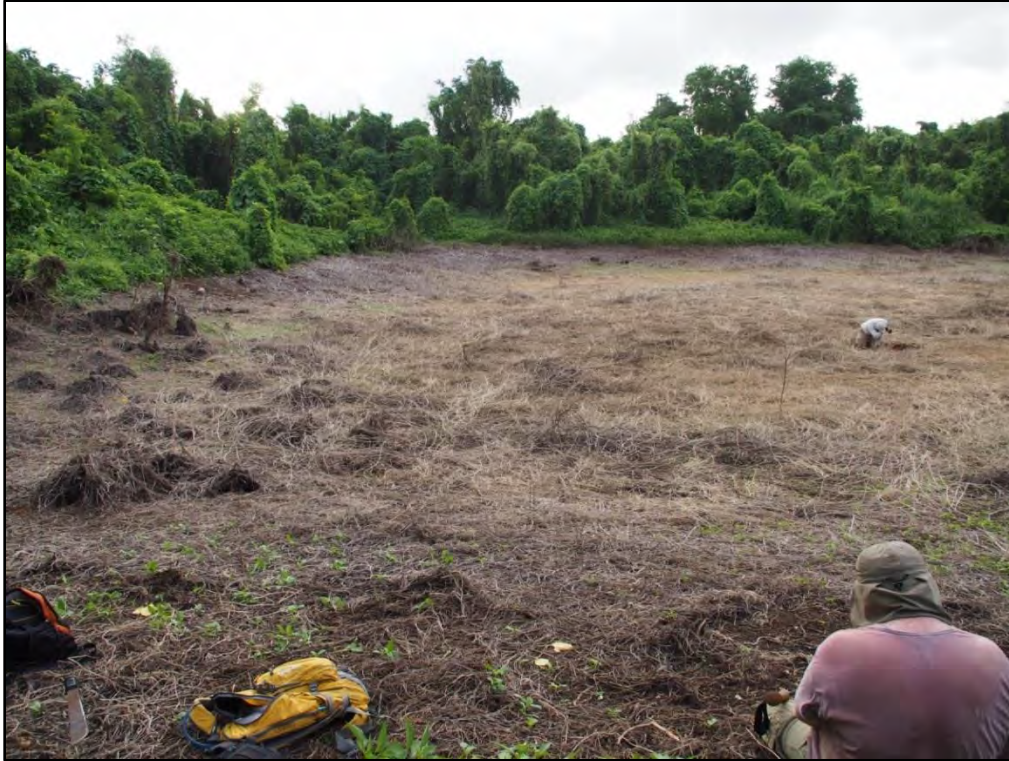
**Figure A-11. Photograph of M11 taken on December 3, 2014 showing dead vegetation as a result of previously ponded waters during the survey period.**

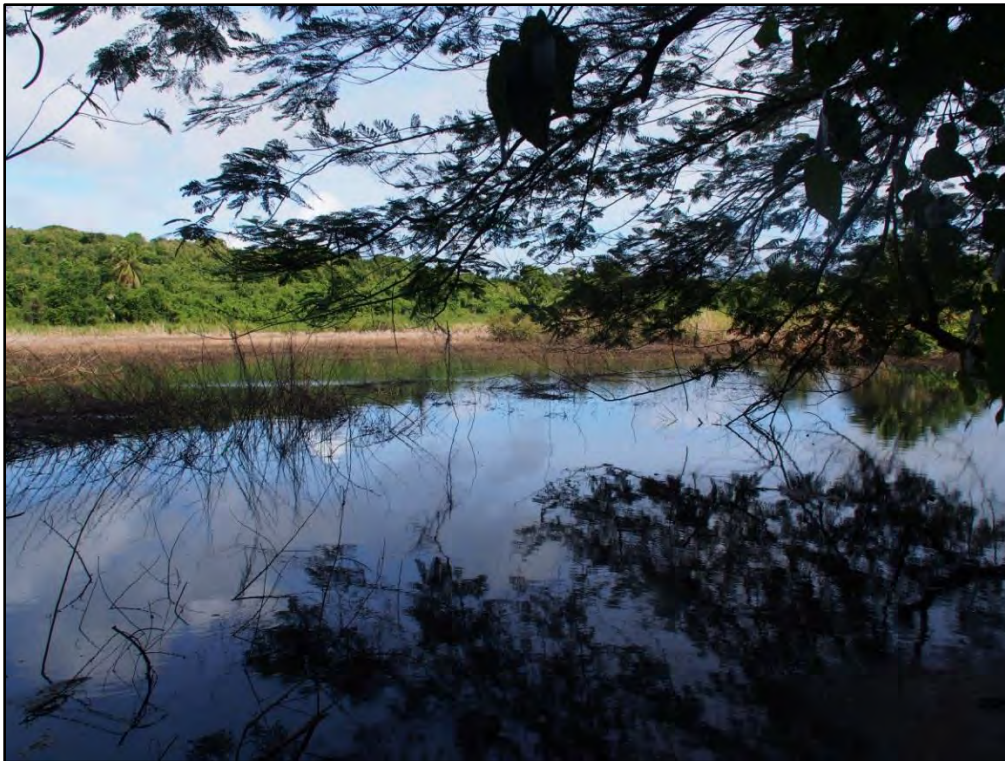
**Figure A-13. Photograph of BD1 showing level of ponded waters on December 2, 2014. Dead upland vegetation from previously ponded waters is shown in background.**

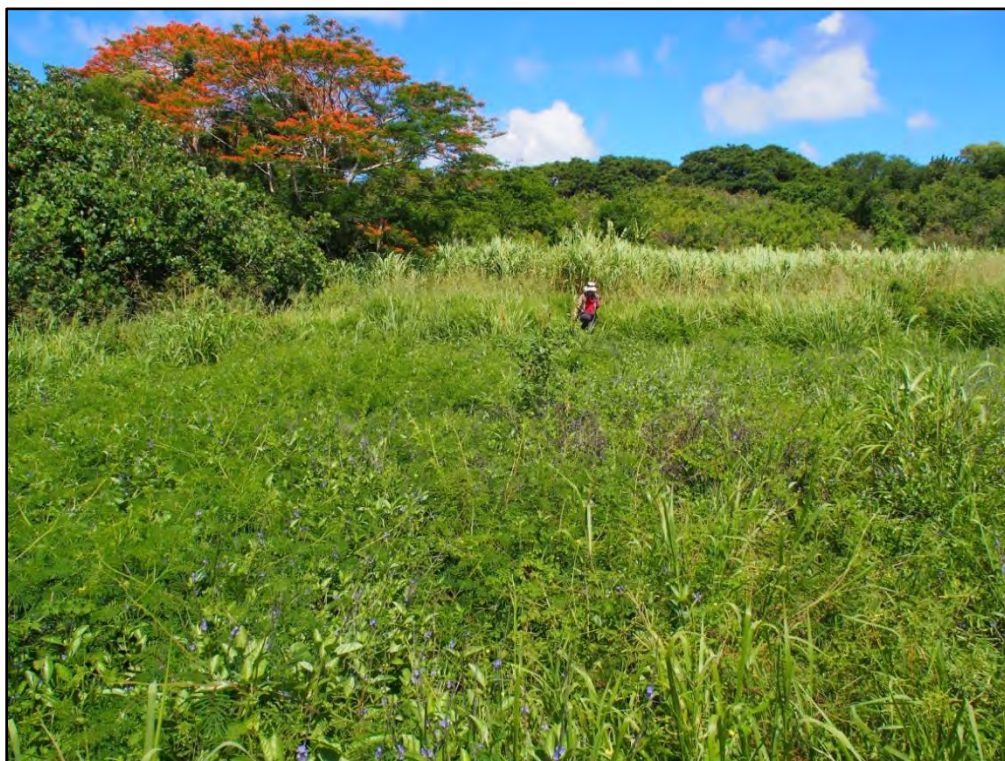
**Figure A-14. Photograph of BD1 taken on July 3, 2013 showing open field (upland) vegetation dominating the landscape.**

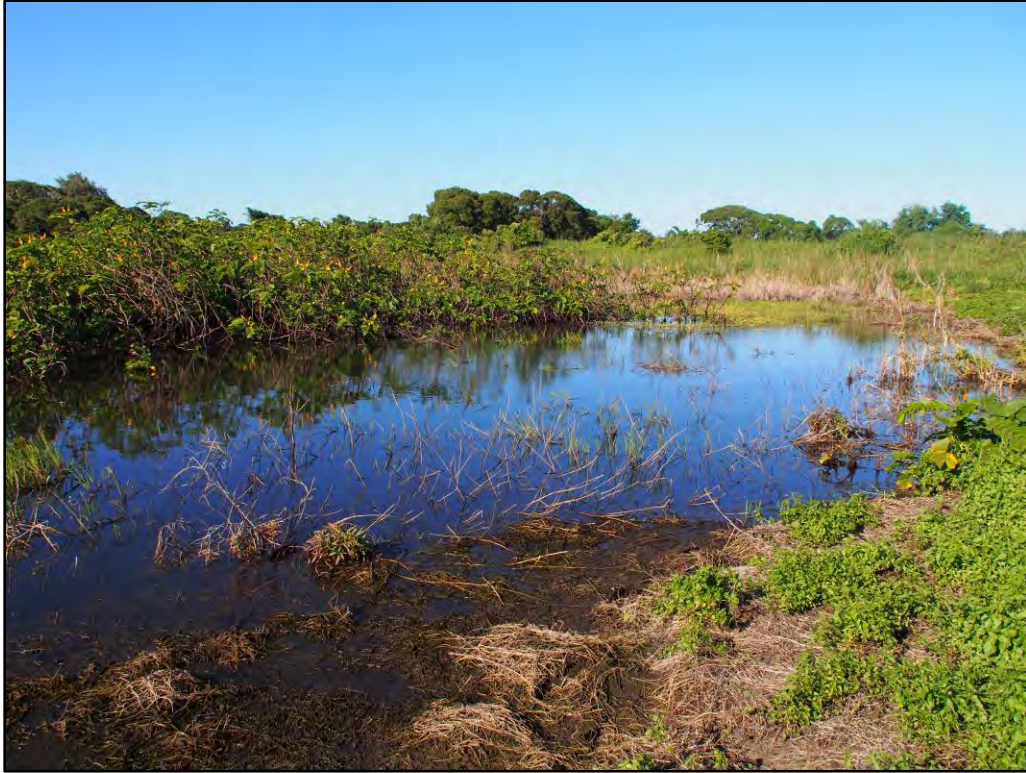
**Figure A-15. Photograph of BD2 taken on December 1, 2014 showing level of ponded waters during the survey period.**

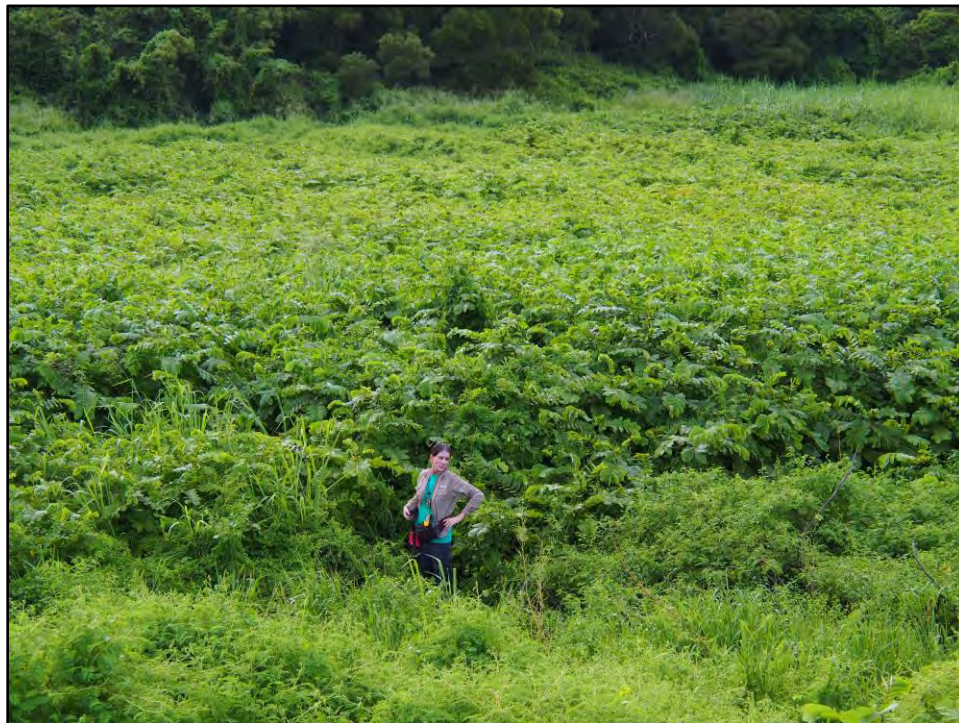
**Figure A-16. Photograph of BD2 on July 16, 2013 showing no ponded waters with the formerly flooded area dominated with open field vegetation.**
